DOT HS-801-969

# CRASHWORTHINESS OF THE SUBCOMPACT VEHICLE

August 1976

Final Report

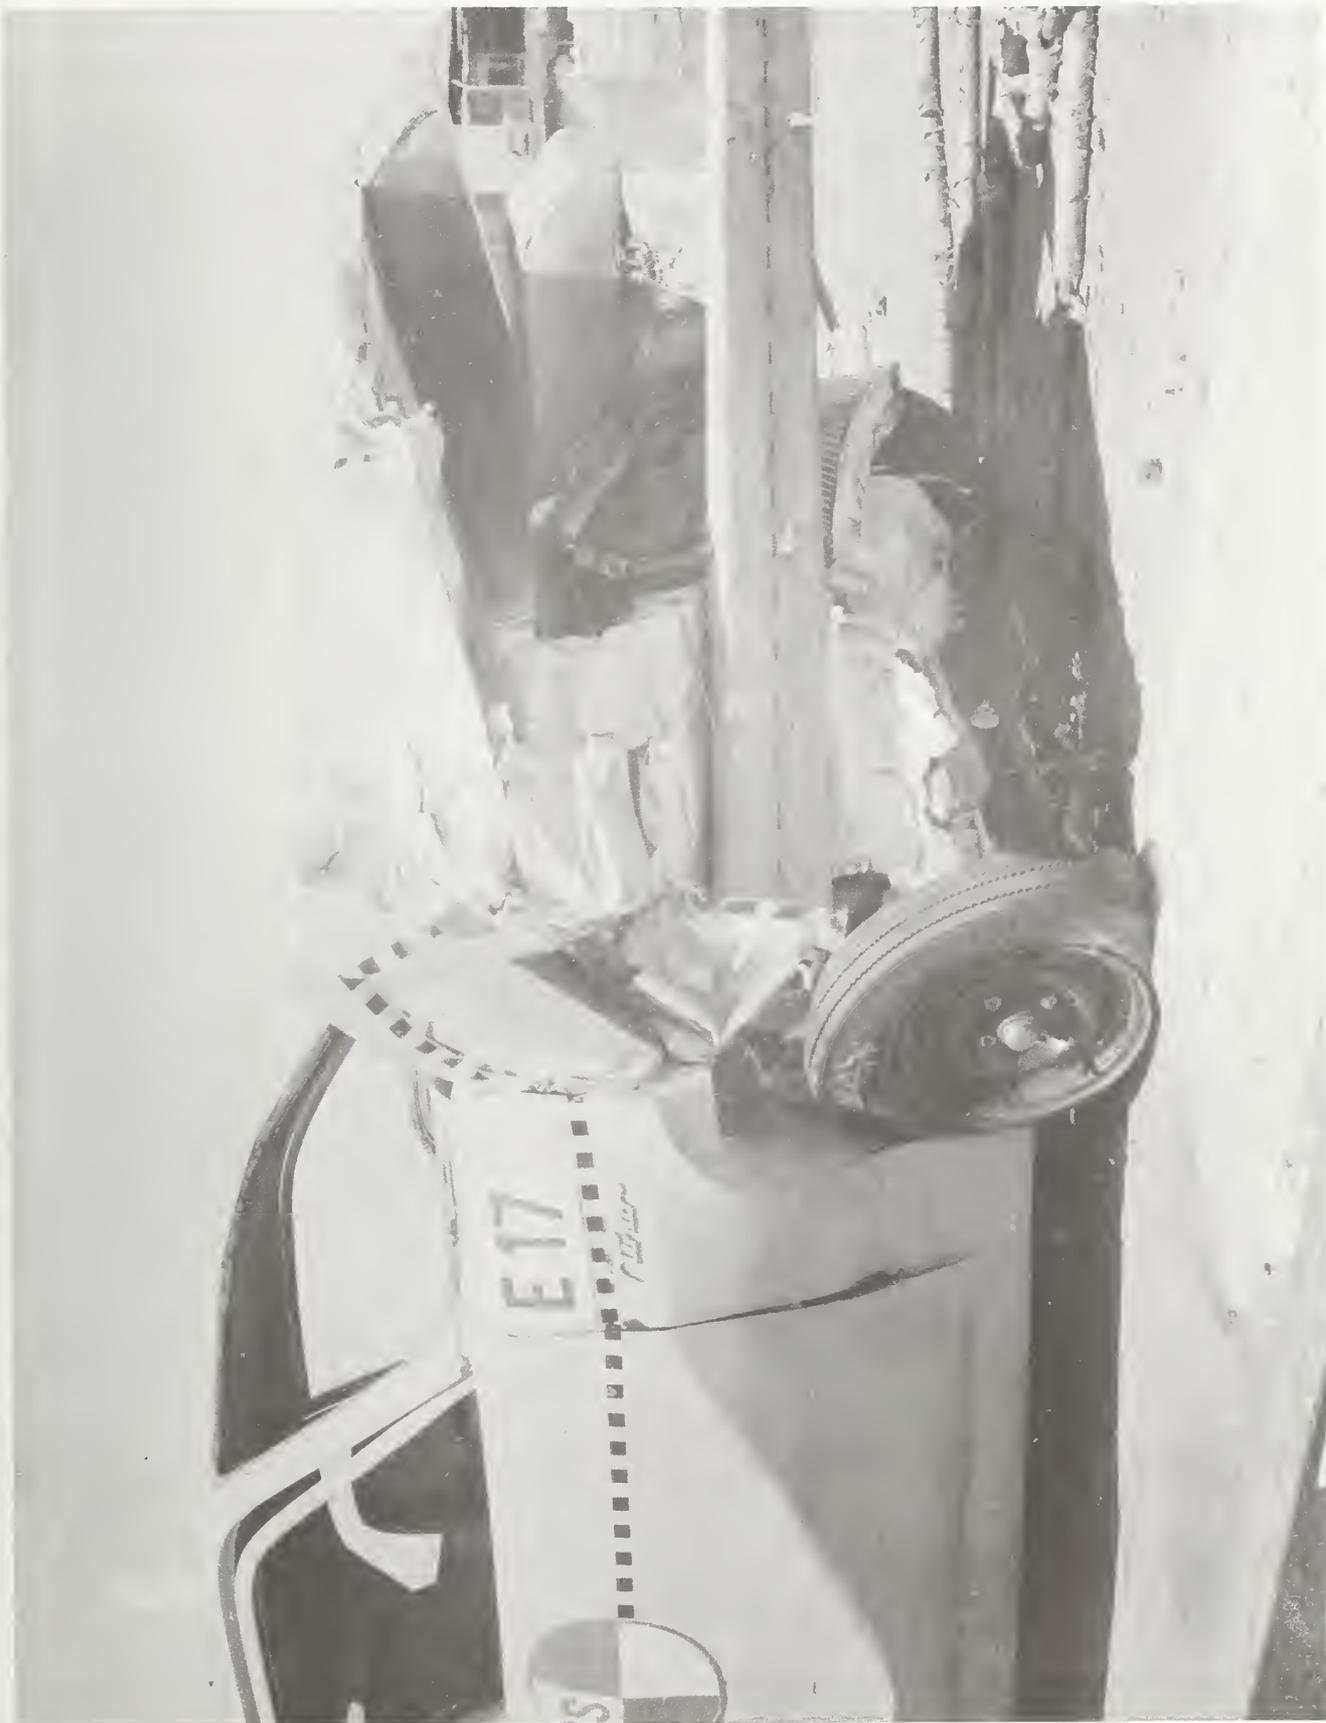
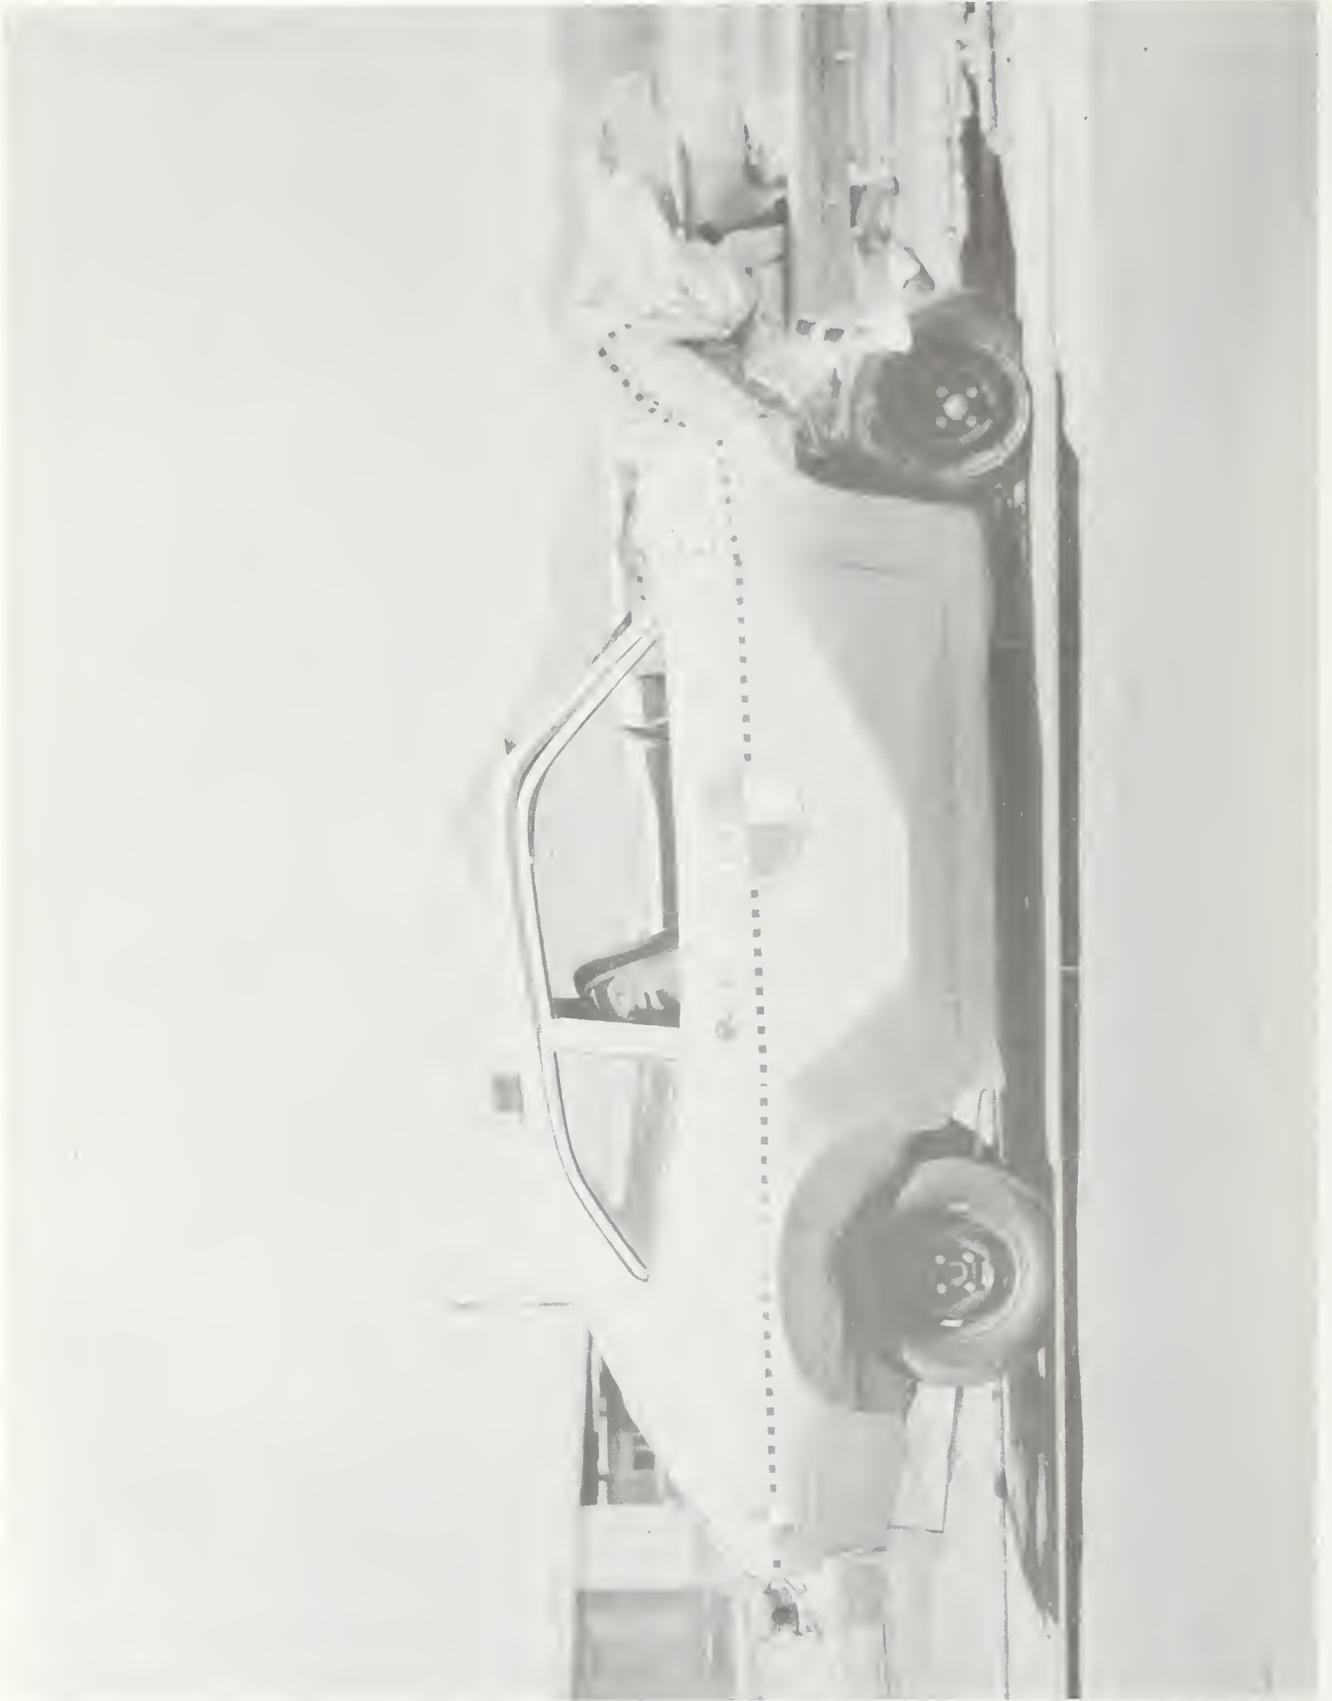
B. Right Front Quarter Post-Test View of Pinto  
FIGURE 3.45 CONT'D

C. Right Side Post-test View of Pinto

Evaluation Test E17 was similar to Baseline Test 06 except the test vehicle was a modified Pinto sedan and the nominal closing velocity was reduced to 70 mph. As before, the vehicles were offset 50 percent of the width with parallel velocity vectors. The instrumentation and photographic coverage were the same as used in Baseline Test 06. The data is summarized in Table 3.10, with photographs in Figure 3.45. The complete test report was presented as an attachment to the September 1974 progress report.

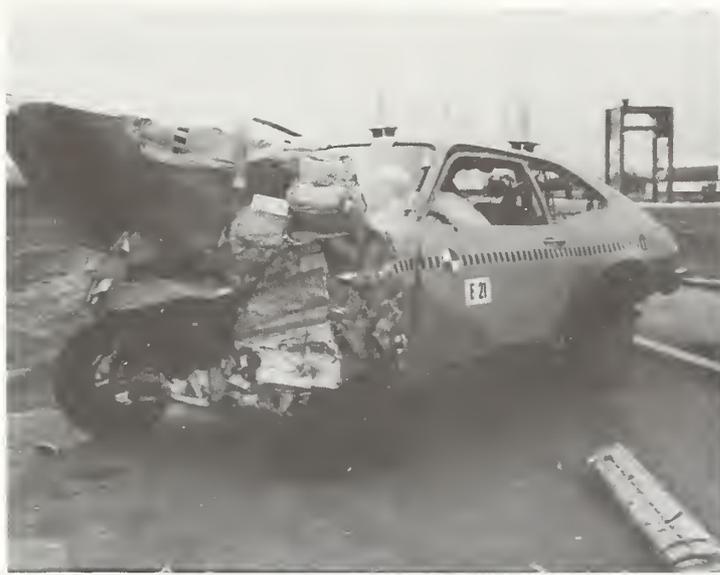
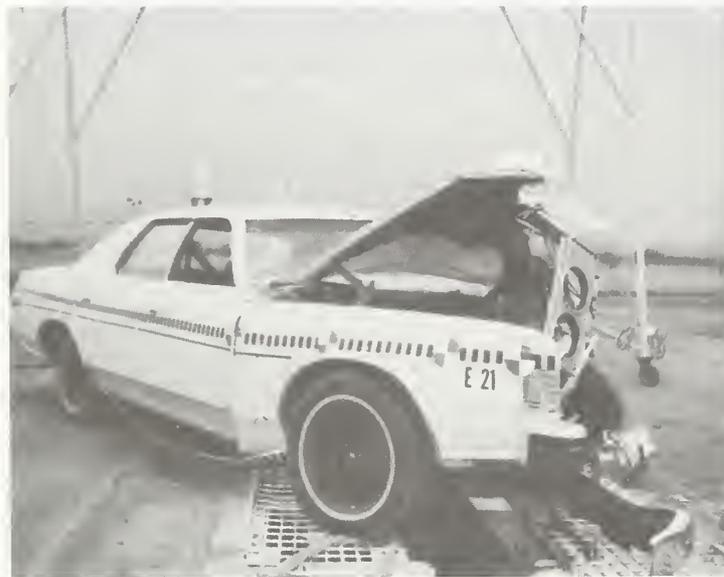
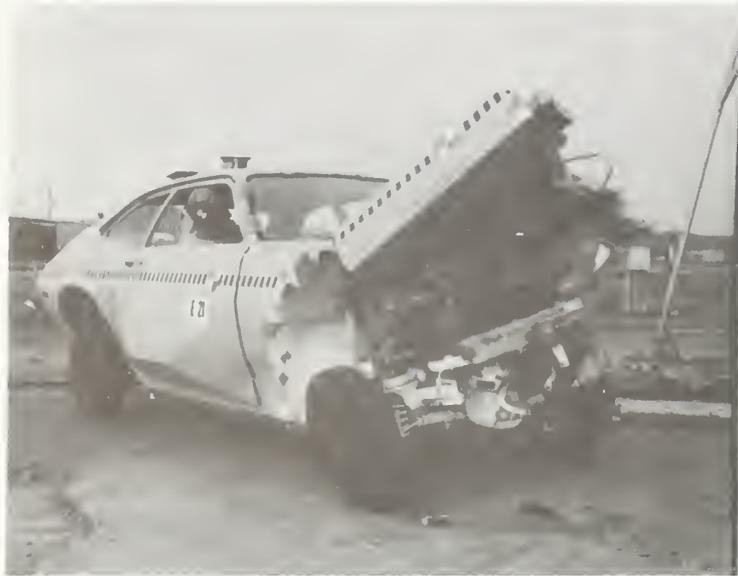
FIGURE 3.46 PHOTOGRAPHIC COVERAGE  
OF TEST E21

A. Left Front Quarter Damage

B. LTD Damage

C. Right Front Quarter Damage

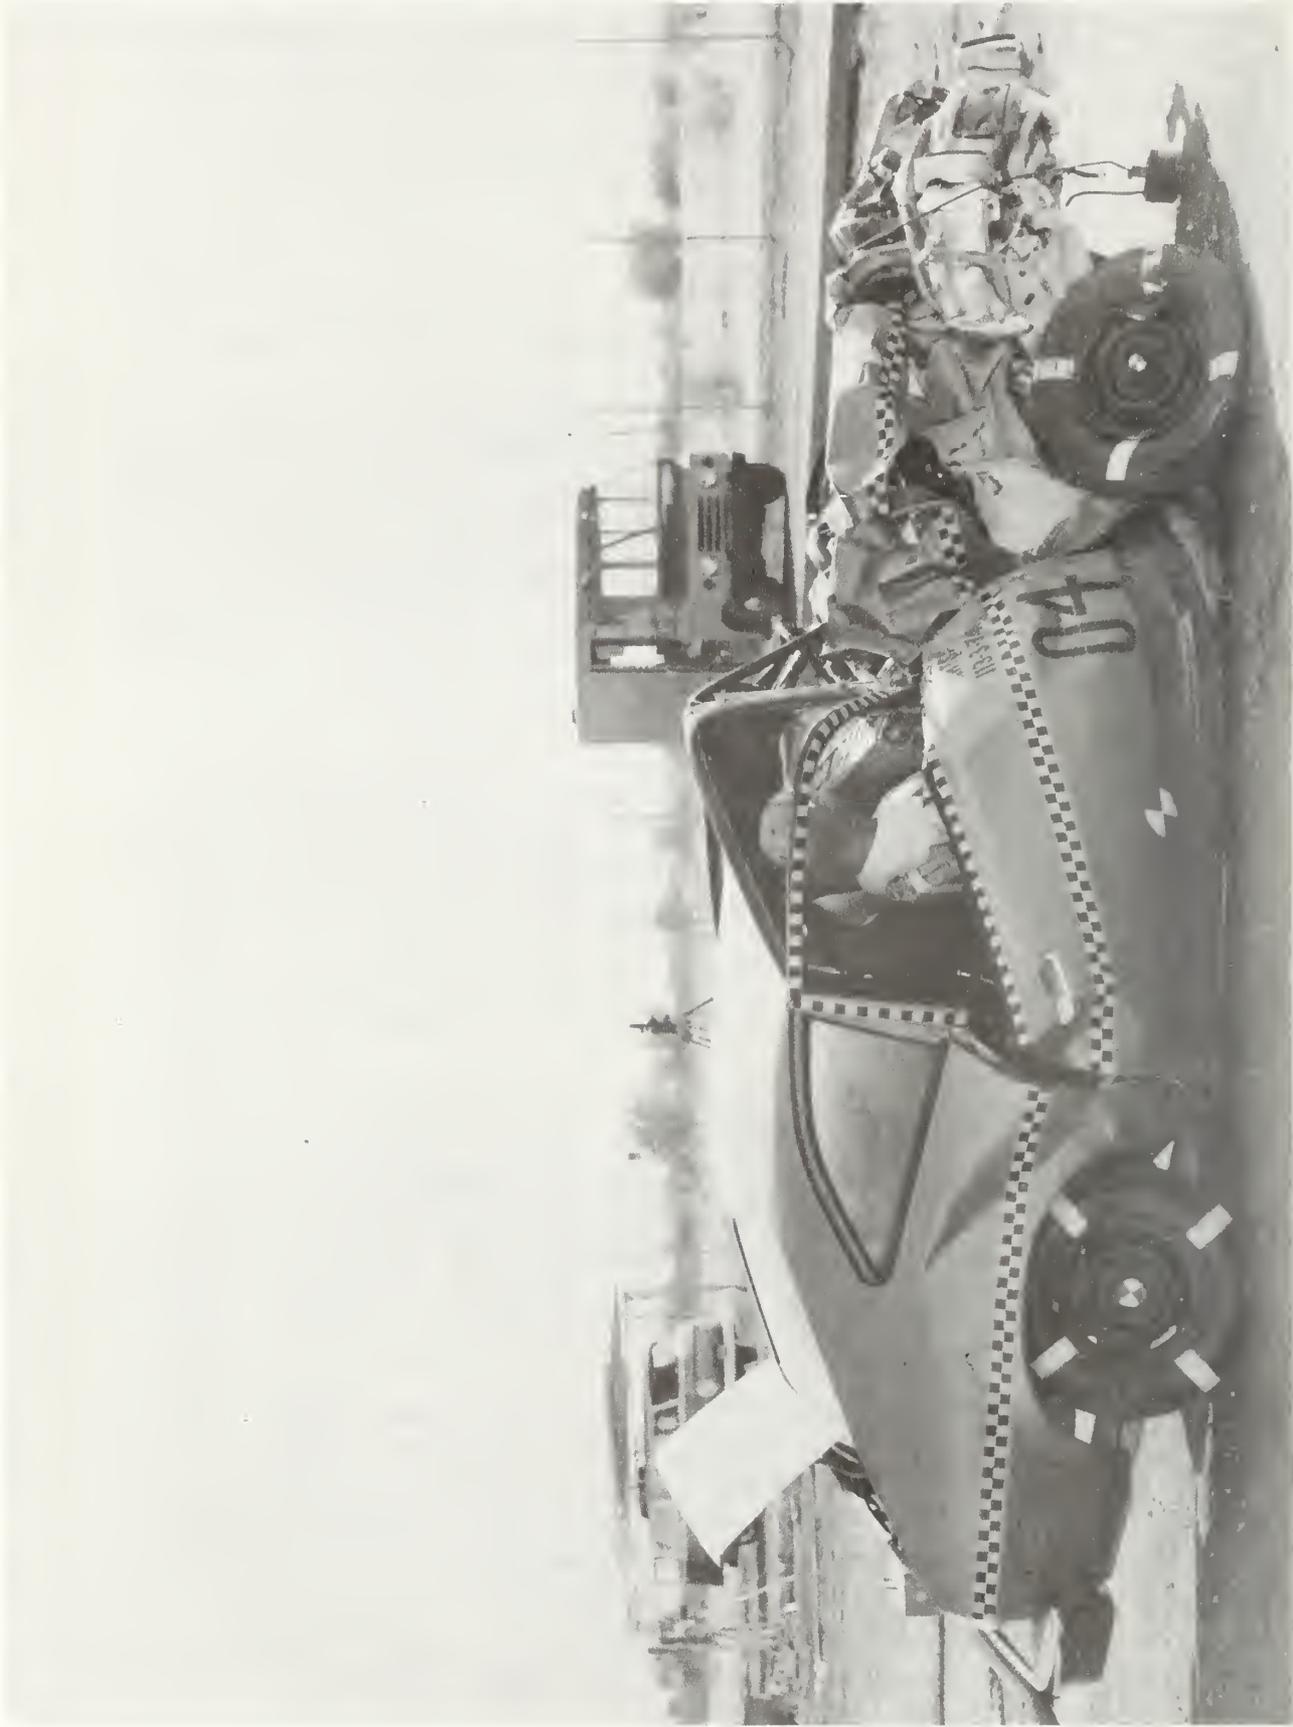
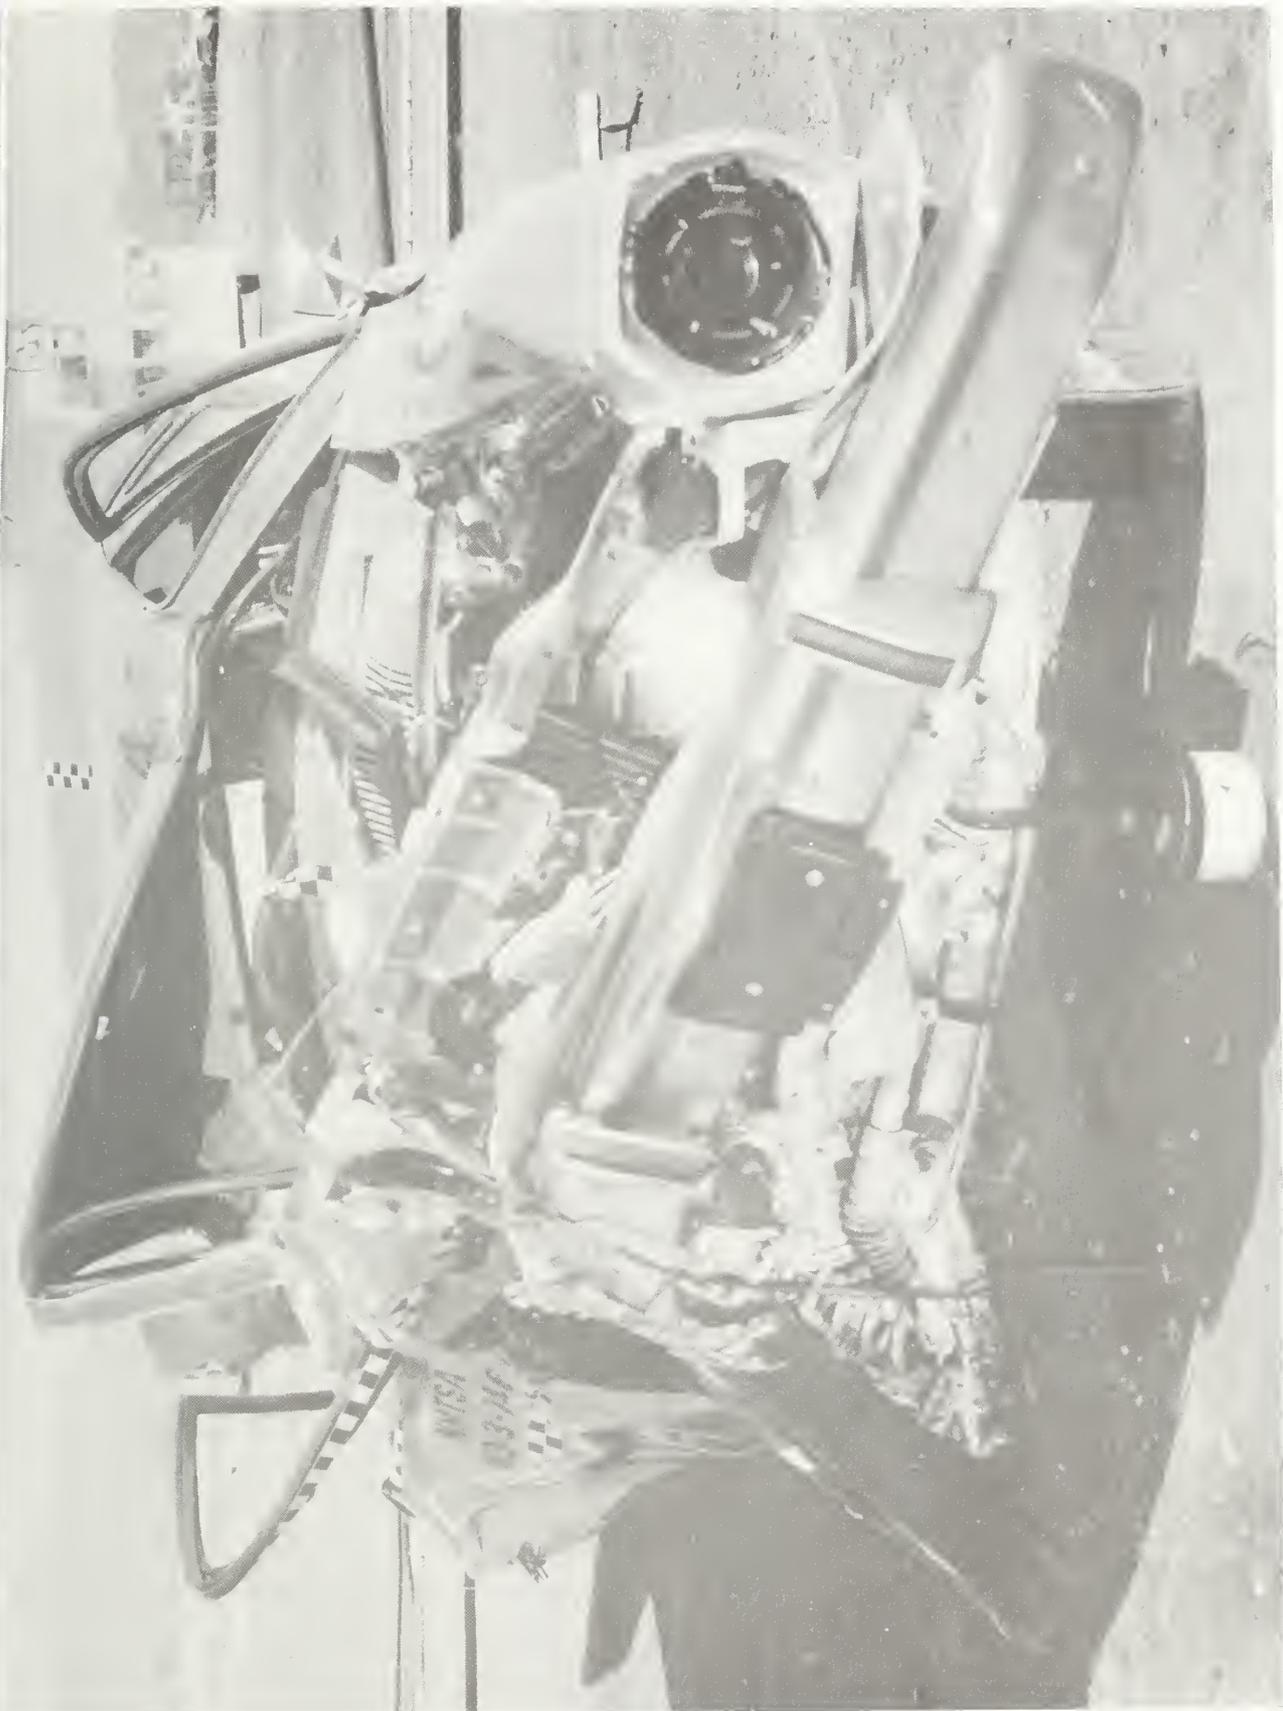
FIGURE 3.47 PHOTOGRAPHIC COVERAGE OF BASELINE TEST 07

A. Post-test Side View of Pinto

B. Post-test Front View of Pinto

The structural damage to the Pinto was similar to the results of Test 06. The left side of the vehicle bent away from the impact, making the vehicle concave on the left side. This is the reverse of the curvature due to the offset impact. Based on preliminary data, the acceleration levels experienced by the dummy are below the critical levels. There appears to be adequate living space between the seat and dash in the vehicle after the crash, although the door opening allowed the dummy to rotate out of the compartment and caused probably fatal head strikes. The Plymouth sedan overrode the Pinto, making a spectacular visual effect. Based on the results of Tests E15 and E17, it is believed that the modified vehicle would have proved crashworthy under the accident conditions.

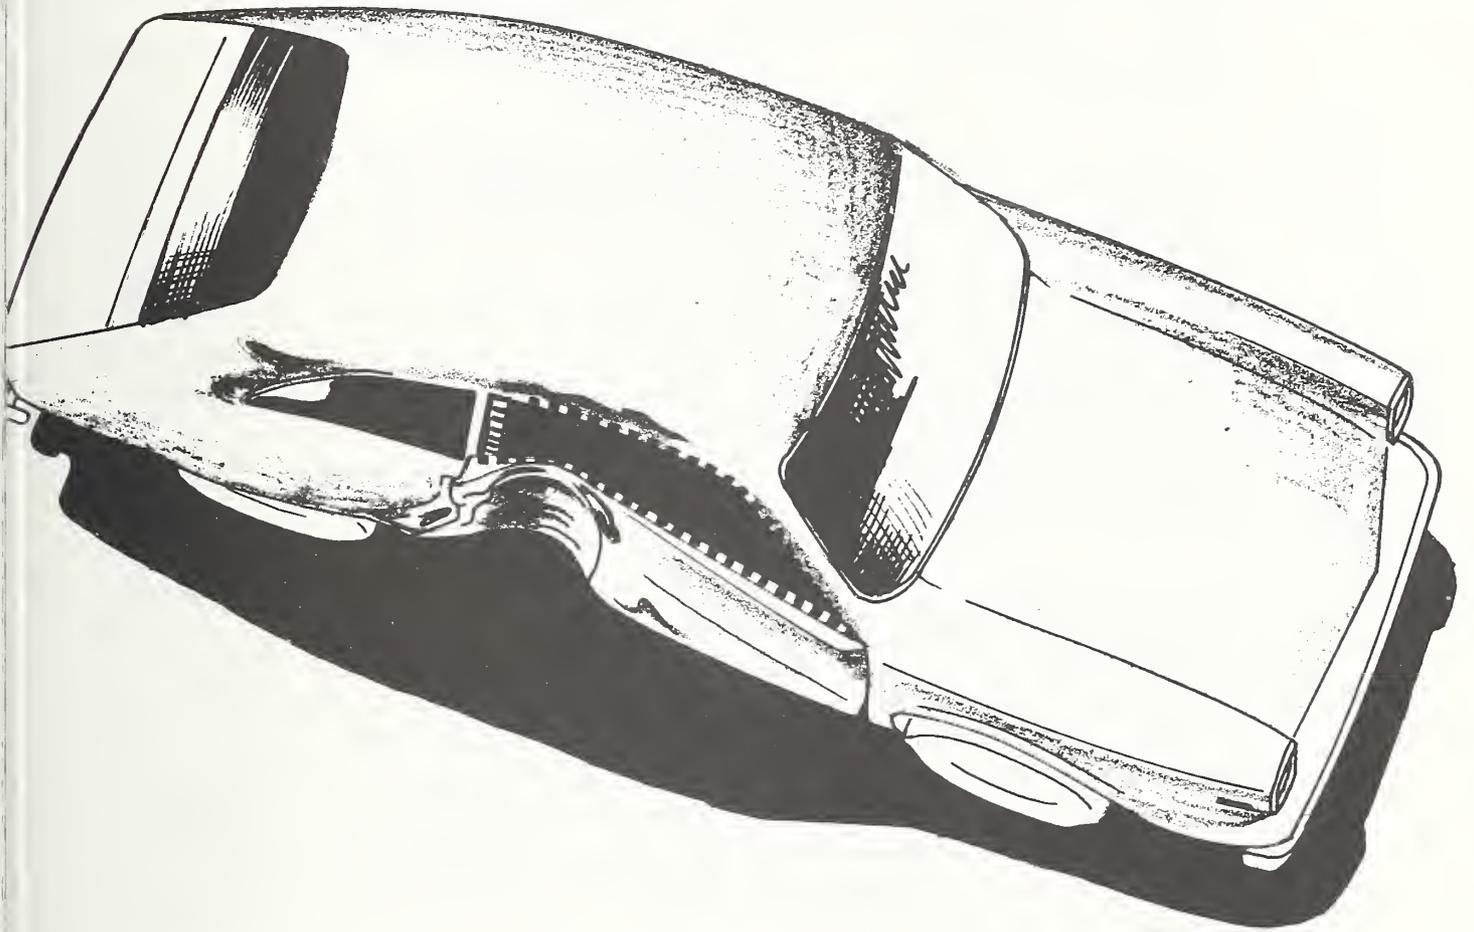
FIGURE 4.1 TYPICAL SIDE POLE IMPACT DAMAGE

The vehicle-to-vehicle side impact crashworthiness presents a completely different problem from the frontal impact criteria. The crush distance available in the subcompact vehicle for side impact is, at most, 10 inches. Some of

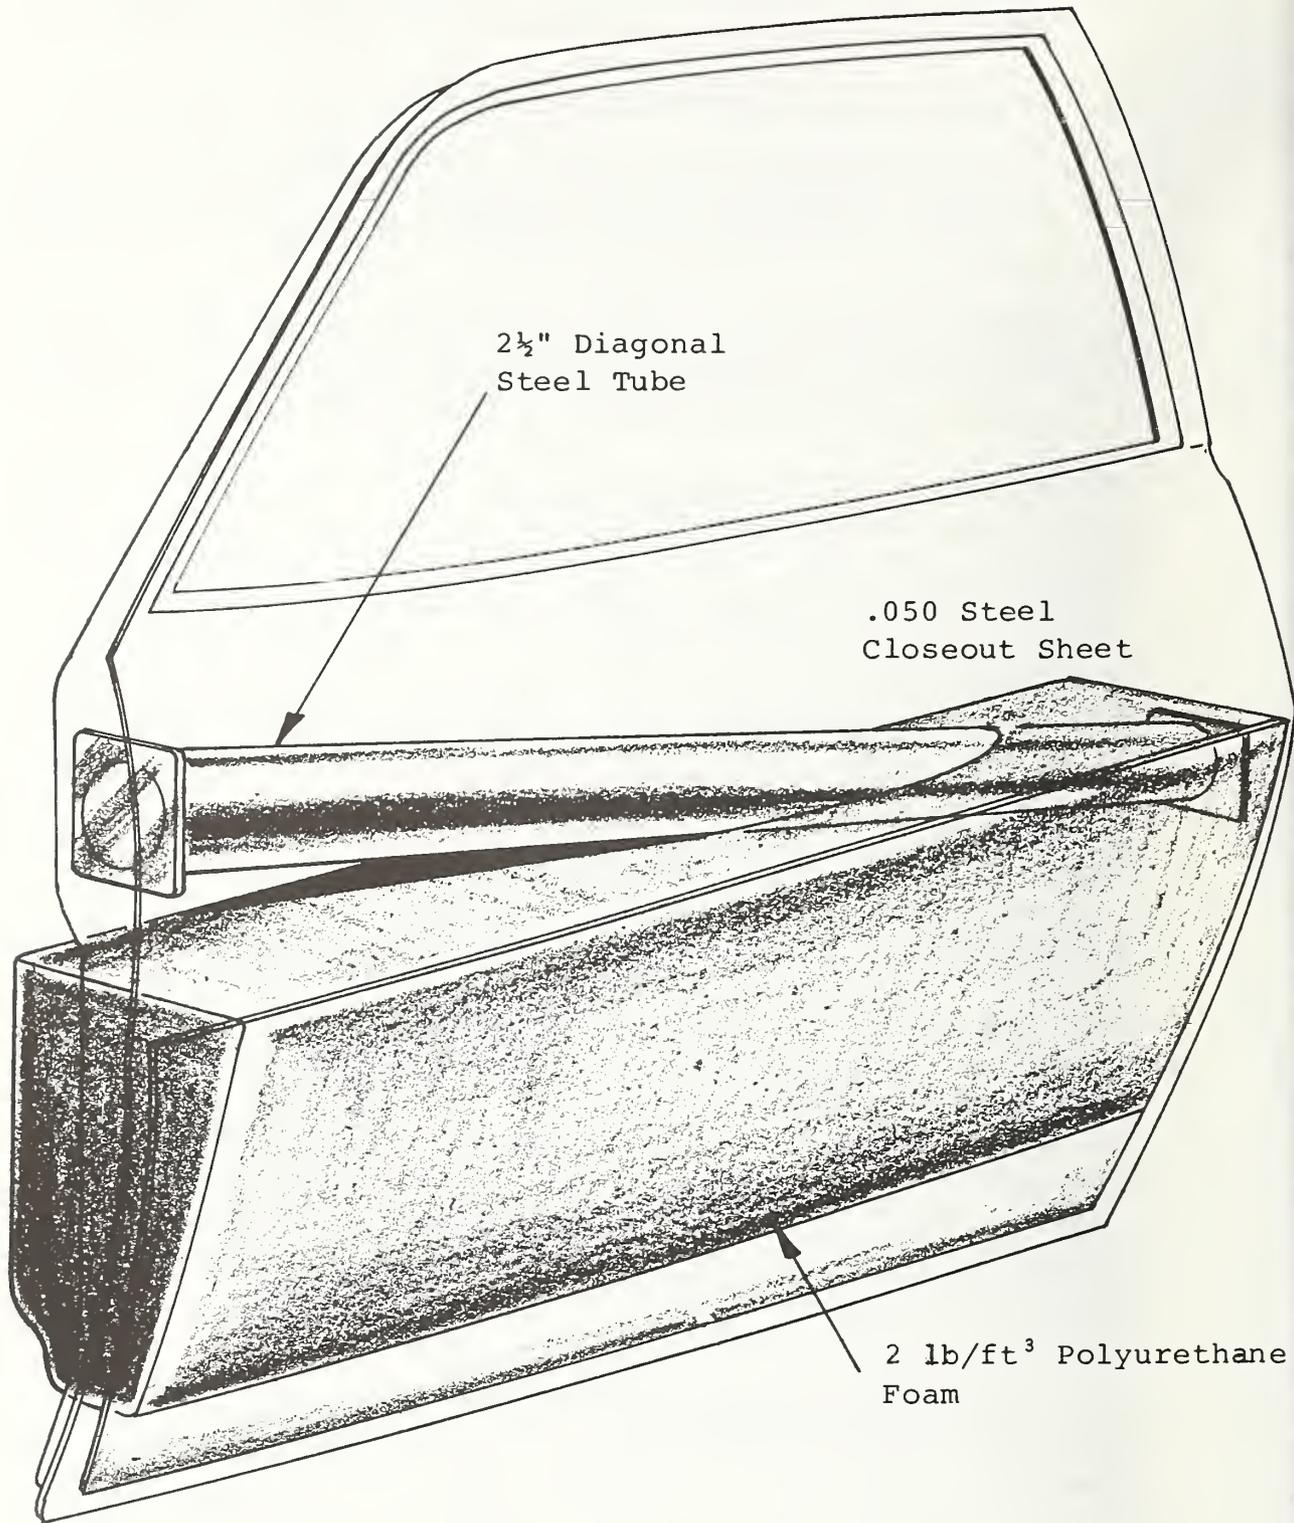
FIGURE 4.2 DOOR MODIFICATIONS

The compartment laterals, at the B post and under the front seat, are formed as an integral part of the new underbody. The front seat lateral is 9 x 16 inches and is made from 18 gage steel. It runs laterally from the rocker to the tunnel on each side of the vehicle. The top of the

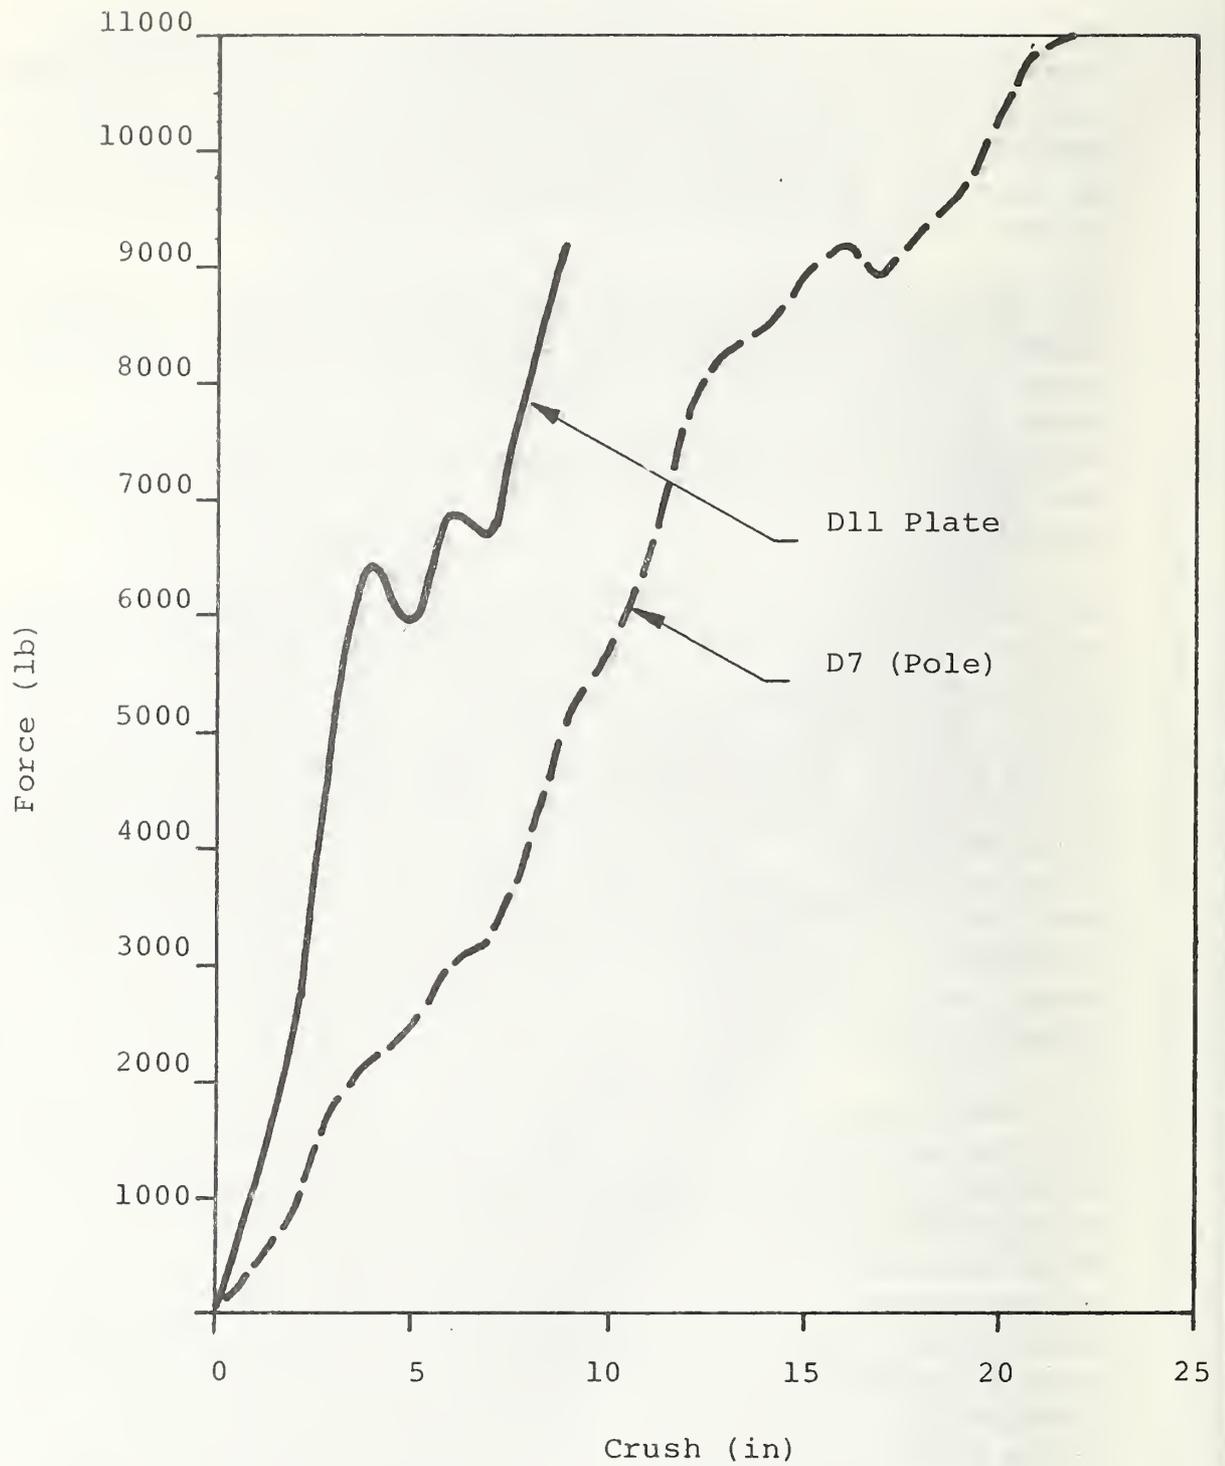
FIGURE 4.4 STATIC FORCE DISPLACEMENT FOR BASELINE  
74 PINTO SIDE STRUCTURE

The tests were run at loading rates of 3 inches/minute for the pole test and 4 inches/minute for the front-to-side test. The data included load cell measurement, displacement measurement, and photographic coverage. Four load cells were used to support the reaction plate of the crusher. The sum of these cells is the total resistance force of the compartment. A linear displacement transducer was used to record the crush distance. Photographic coverage included slow motion film and 35 mm slides taken during the test, as well as pre and post test shots. Figure 4.4 presents the force-deflection data obtained from both D7 and D11. The pole test

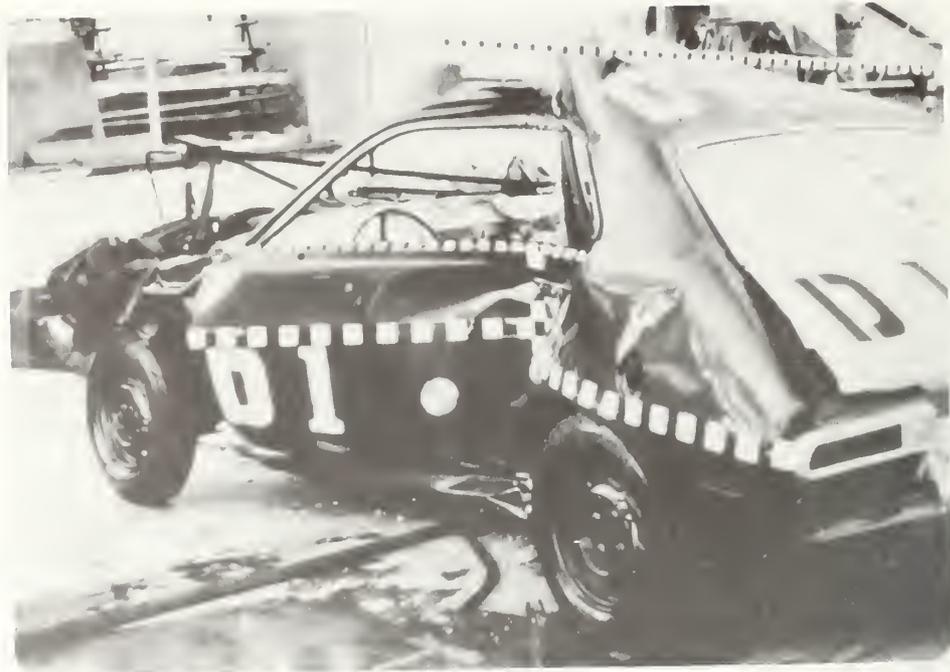
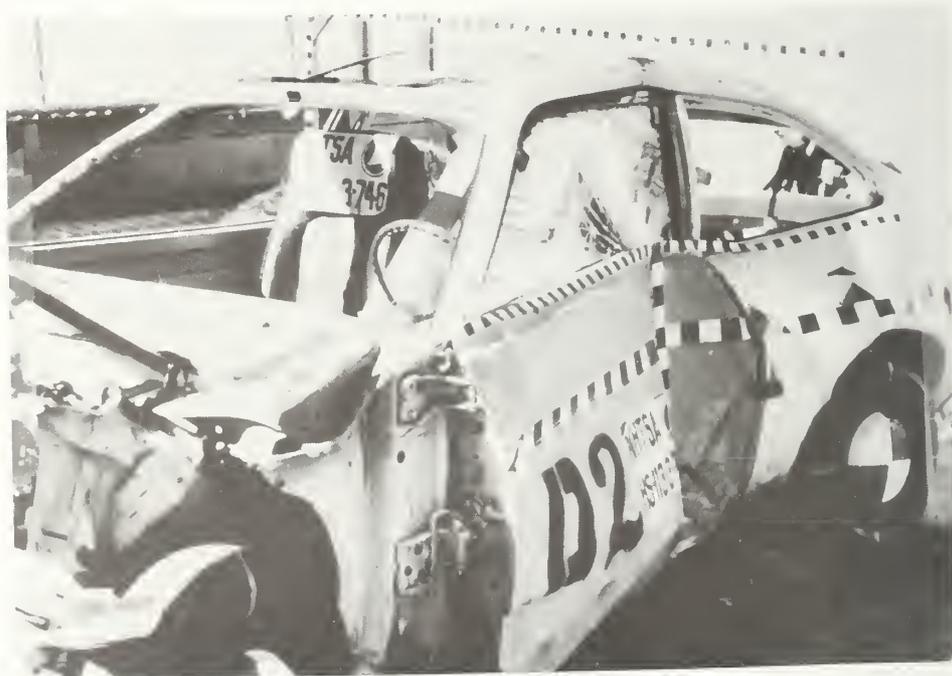
FIGURE 4.7 DYNAMIC SIDE POLE TESTS D1 AND D2

<u>Intrusion</u>	<u>Chest Acc.</u>	<u>Head Acc.</u>
Unmodified	17 in.	46 g's	121 g's
Modified	6 in.	42 g's	78 g's

A. Test D1 Unmodified

B. Test D2 Modified

Table 4.2, with the photographic coverage presented in Figure 4.7. The location of impact, selected by the CTM, was 6 inches forward of the B post. This placed the pole between the proposed lateral stiffening members.

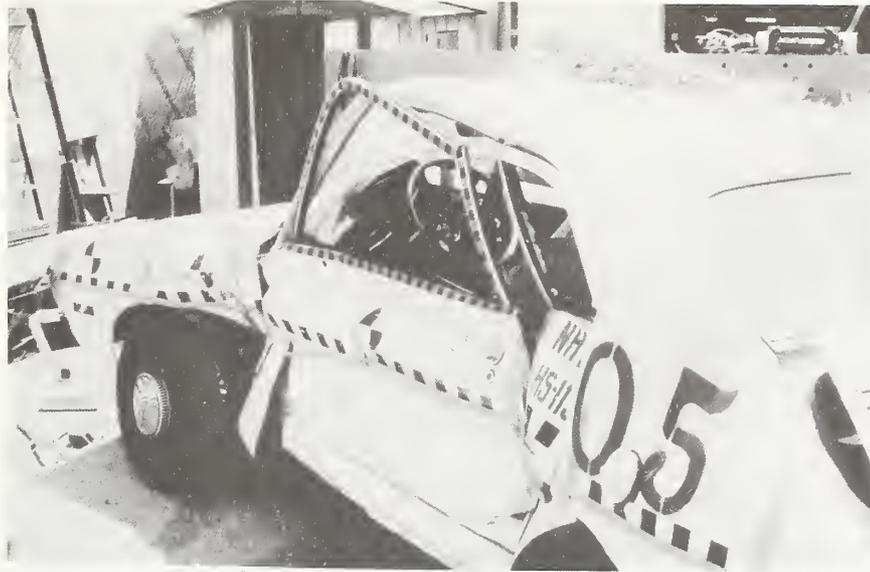
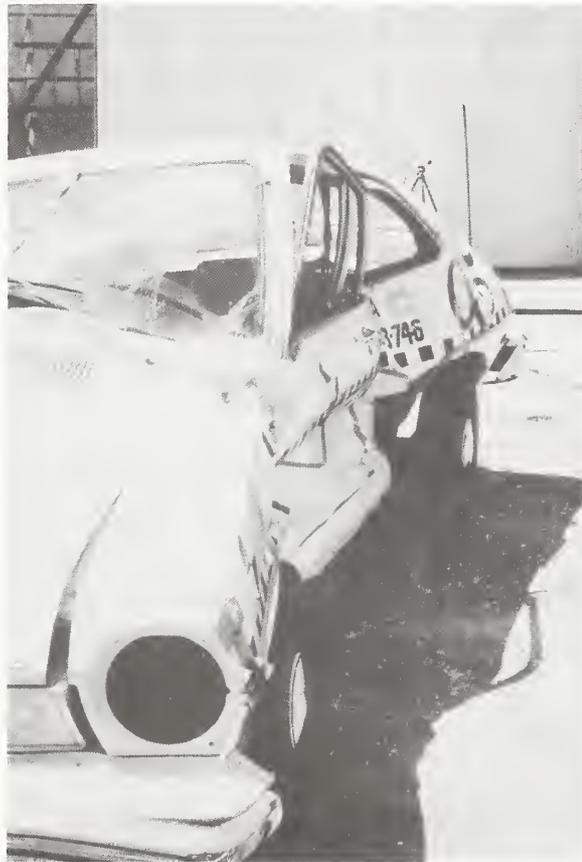
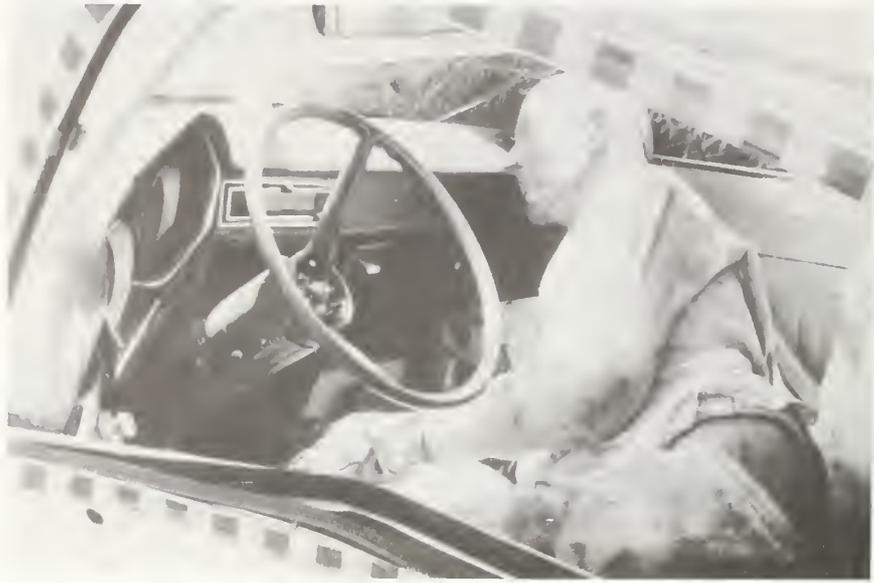
FIGURE 4.8 PHOTOGRAPHIC COVERAGE OF  
BASELINE TEST 05

A. Post Test Left Rear Quarter View

B. Post Test Left Front Quarter View

C. Post Test Dummy Position

according to the baseline test plan. The quantity of data dictated the use of transducers with a past history of poor performance. These units were rewired for this test and were placed in locations of less significant data value. Photographic coverage included four high-speed movie cameras and 35 mm pre and post test stills. In addition, pre and post test physical measurements were taken of both vehicles. The test data is summarized in Table 4.3, with the photographic coverage in Figure 4.8. The complete test report was presented as an attachment to the September 1974 progress report.

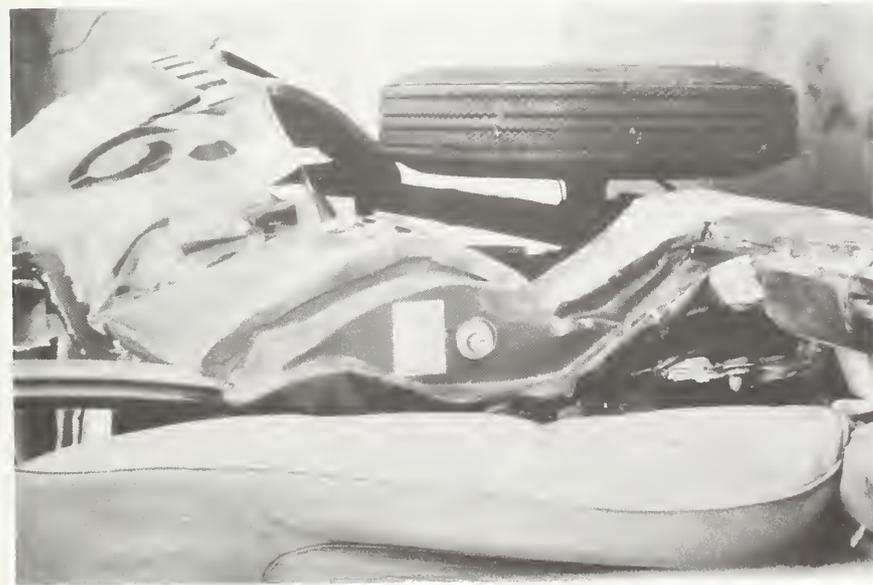
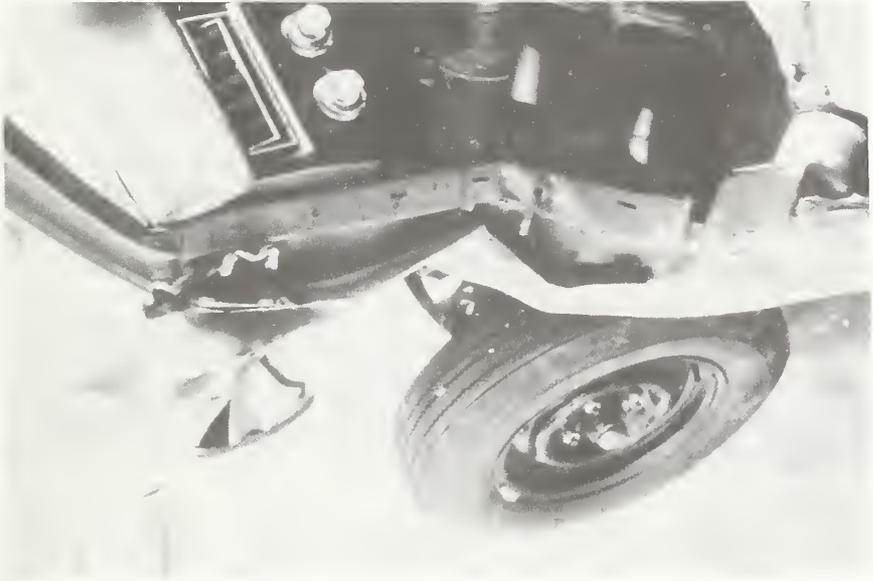
FIGURE 4.9 PHOTOGRAPHIC COVERAGE OF TEST E9

C. B-Post Damage

D. A-Post Damage

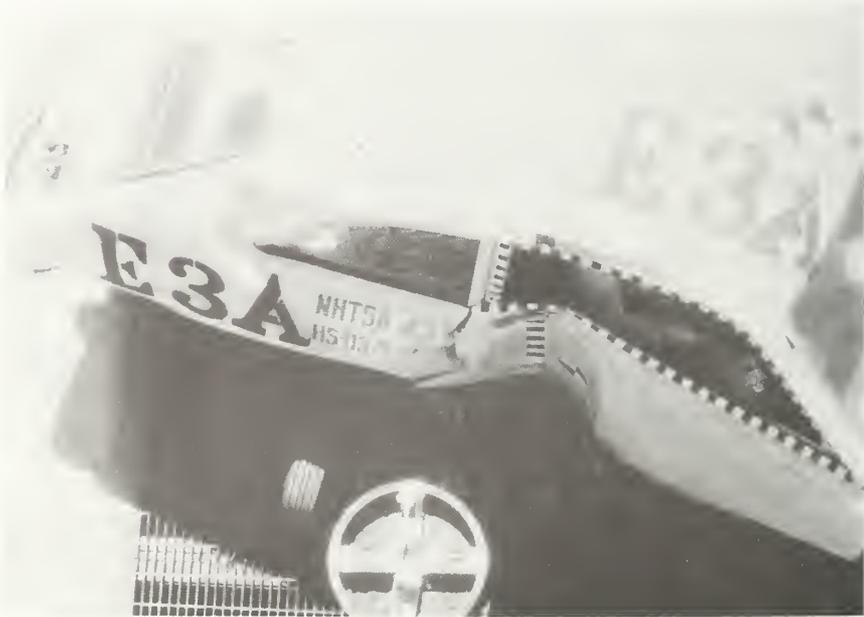
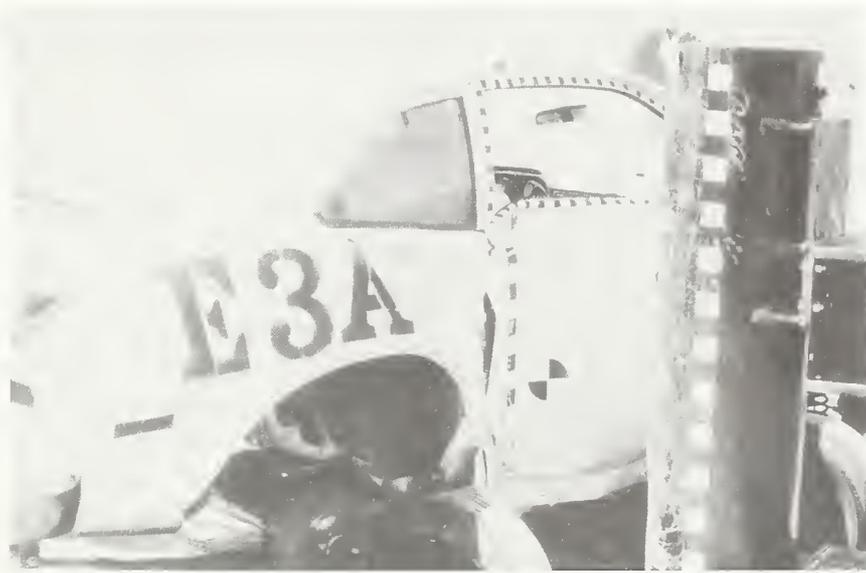
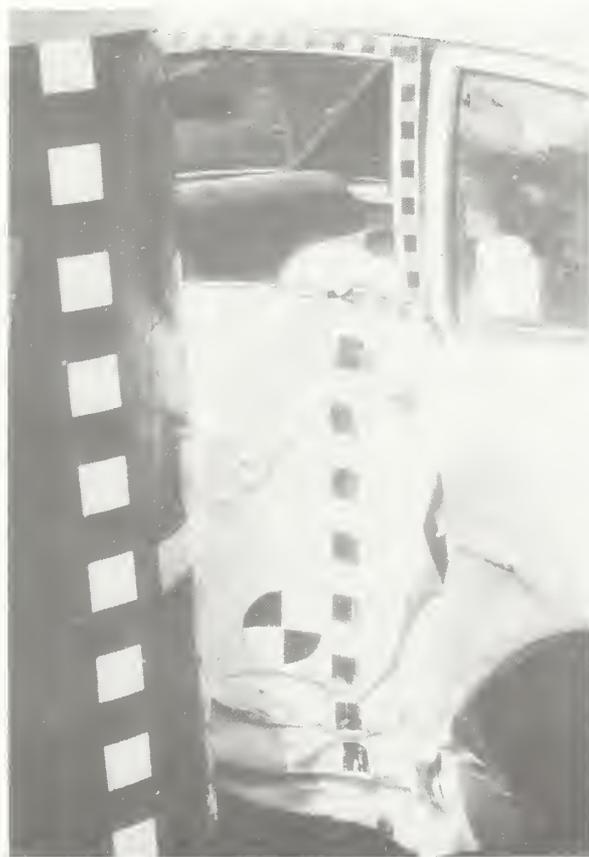
FIGURE 4.11 PHOTOGRAPHIC COVERAGE OF TEST E3A

B. Final Vehicle Position

C. Overall View

D. Side Pole Impacts

The complete test reports for E3 and E3A were presented as attachments to the September 1974 progress report. The physical data is summarized in Table 4.4, with the photographic stills shown in Figure 4.11. Impact velocity of E3 was 18.2 mph and E3A was 18.9 mph.

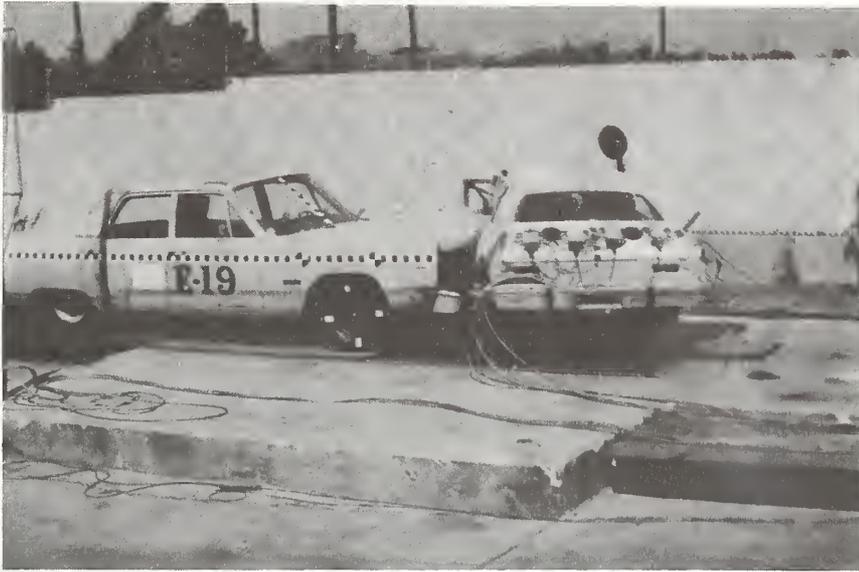
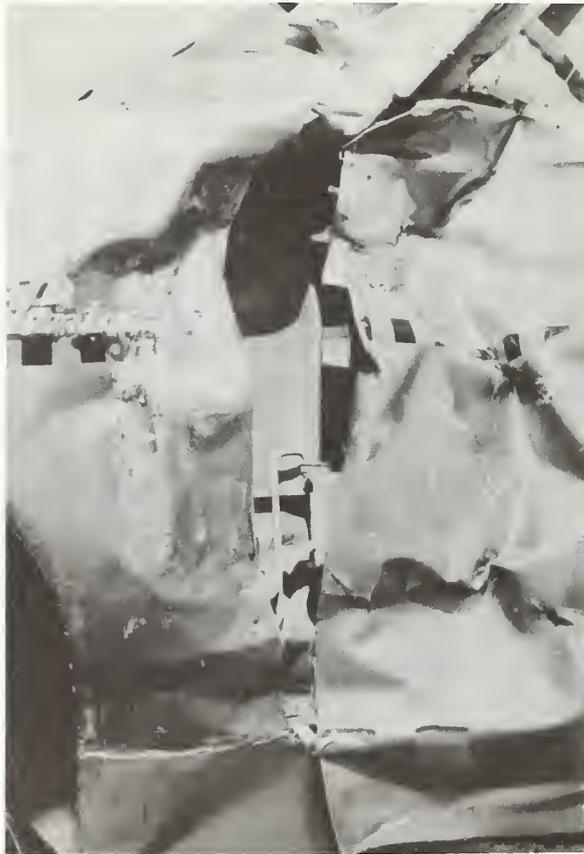
FIGURE 4.14 PHOTOGRAPHIC COVERAGE OF TEST E19

A. Impact

D. Post Test Closeup Side View of Pinto

In all other respects, the data acquisition system corresponded to the Evaluation Test Plan. The test report for E19 was presented in the October 1974 progress report. Table 4.5 summarizes the physical and electronic data. The photographic data is reviewed in Figure 4.14. The actual velocity of impact was 29.4 mph.
